BCS TRANSMISSION PTO COVER REVOVAL & PTO SYSTEM REPAIR— 1995 & NEWER TRACTORS WITH TAPER-3-JAW PTO SHAFT

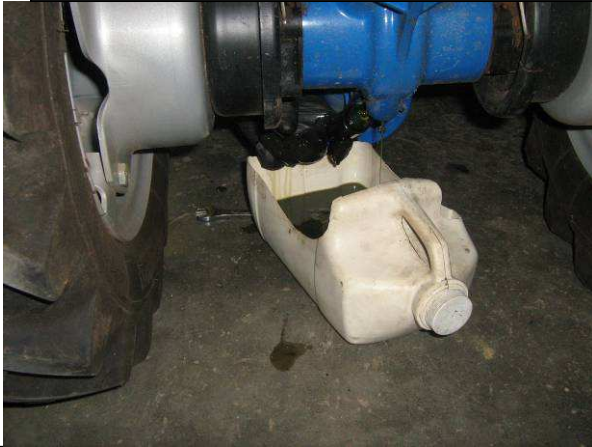
STEP 1. HAVE IMPLEMENT REMOVED FROM TRACTOR, AND HAVE TRACTOR HANDLEBARS IN FRONT-PTO (MOWING) MODE FOR THIS PROCEDURE. *Note: It is recommended to look through this entire document BEFORE starting on the repair, so you can get together all the tools / materials you will need...*

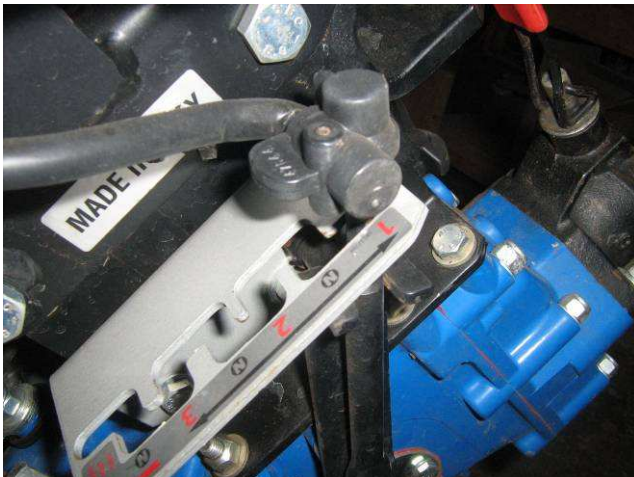
3. REMOVE COTTER PIN FROM PTO SHIFT ROD, AND REMOVE ROD FROM SHORT UP-RIGHT LEVER

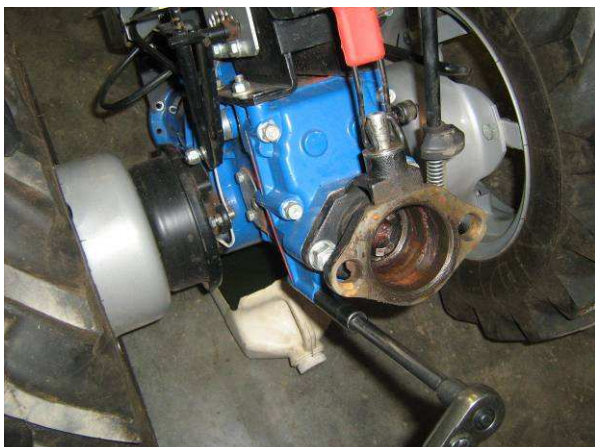
5. REMOVE TWO VERTICAL BOLTS AFFIXING HANDLEBAR SUPPORT TO TRANSMISSION PTO COVER (ONE ON EACH SIDE), THEN LOOSEN 2 NUTS IN FRONT OF THOSE BOLTS 1 TURN EACH

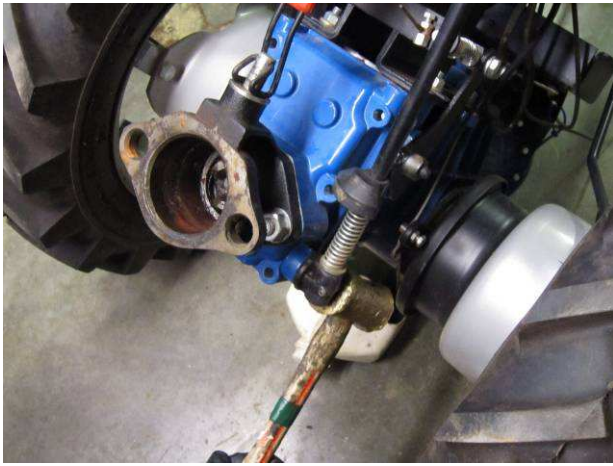
7. USING A SOFT-FACED HAMMER, START TAPPING THE PTO COVER OFF, STRIKING ON THE INSIDE FLANGE OF QUICK-COUPLING (IF EQUIPPED) AND/OR....(SEE #8)

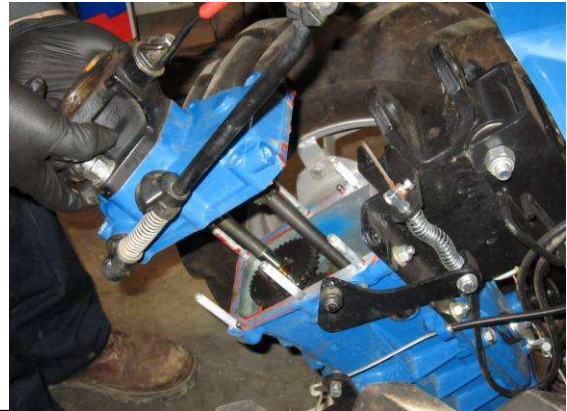
9B. ...THEN THIS ACCESS COVER MUST BE REMOVED, AND THE OFFENDING BEARING, WHICH WILL BE VISIBLE ON THE LEFT SIDE OF THE ACCESS HOLE (*THIS BEARING IS KEEPING THE COVER FROM BEING PULLED OFF, AS IT WEDGES UNDER A LARGE GEAR ON THE UPPER GEAR CLUSTER*), MUST BE KNOCKED OFF THE END OF THE LOWER SHAFT USING A LARGE FLAT-BLADE SCREWDRIVER OR A CHISEL. ONCE THE BEARING IS OFF THE SHAFT, IT WILL STAY IN IT'S "POCKET" IN THE TRANSMISSION CASING. **VERY IMPORTANT:** BEFORE YOU START WHACKING THE BEARING OFF THE SHAFT, YOU MUST INSERT A WEDGE OF SOME SORT IN THE GAP YOU HAVE OPENED UP BETWEEN THE TRANSMISSION HOUSING AND THE PTO COVER. OTHERWISE, HITTING ON THE BEARING WILL PULL THE PTO COVER BACK ONTO THE TRANNY, AS THE SHAFT & COVER ARE HELD TOGETHER BY A SNAP-RING.

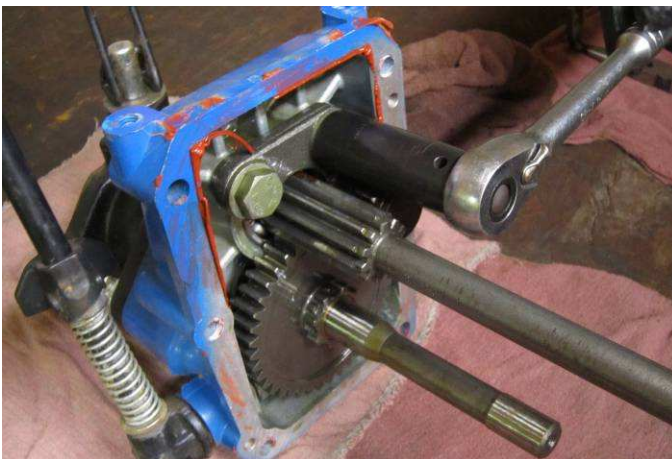
10. ONCE THE COVER IS FREE, SIMPLY PULL IT OFF. THE UPPER AND LOWER SHAFTS WILL COME OUT WITH THE COVER. WITHOUT THE LOWER SHAFT TO SUPPORT IT, THE LOWER GEAR CLUSTER WILL REST ON THE BOTTOM OF THE TRANSMISSION HOUSING. IT CAN BE LEFT THERE UNTIL RE-ASSEMBLY, UNLESS IT NEEDS TO BE REMOVED FOR SERVICING.

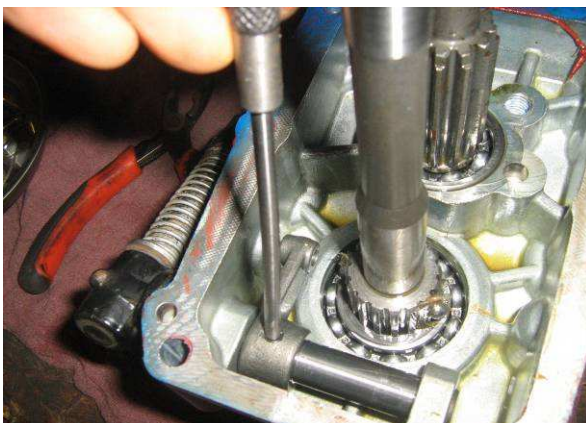
15. RETRIEVEING PTO BALL WITH A MAGNET (THERE ARE 2). NOTE PTO TENSION SPRING JUST TO RIGHT, WHICH HAS FALLEN OUT OF SHAFT IN PICTURE. SPRING NORMALLY GOES THROUGH HOLE IN CENTER OF SHAFT, AND HAS A BALL AT EACH END TO PUSH OUT AGAINST PTO SLIDER, TO MAKE IT "CLICK" INTO POSITION WHEN SHIFTED.

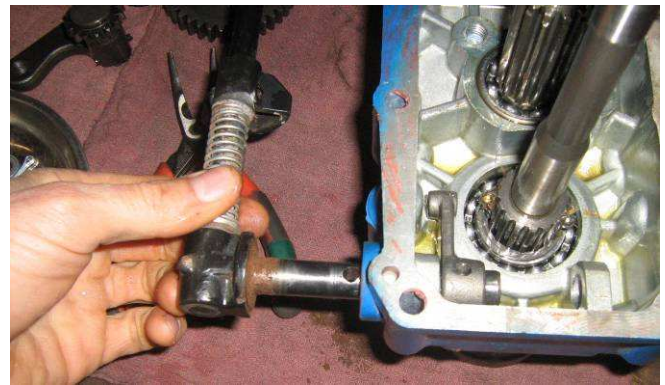
16. USING A 3/16" PUNCH, DRIVE OUT THE ROLL PIN THAT SECURES THE INTERNAL SHIFT LEVER TO THE EXTERNAL LEVER. THERE IS A "POCKET" CAST INTO THE HOUSING TO ALLOW YOU TO DRIVE IT OUT.

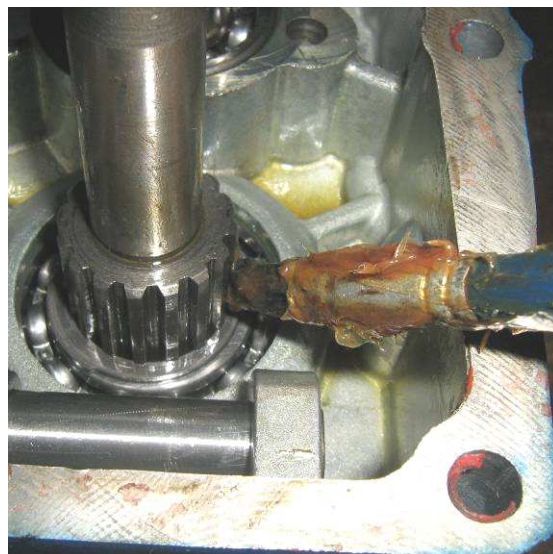
21. RE-ASSEMBLY RE-INSERT PTO DETENT SPRING INTO HOLE THROUGH PTO SHAFT. (IF THIS SPRING IS DAMAGED OR DEFORMED, **REPLACE IT!** IT IS ONLY A BUCK OR TWO.)

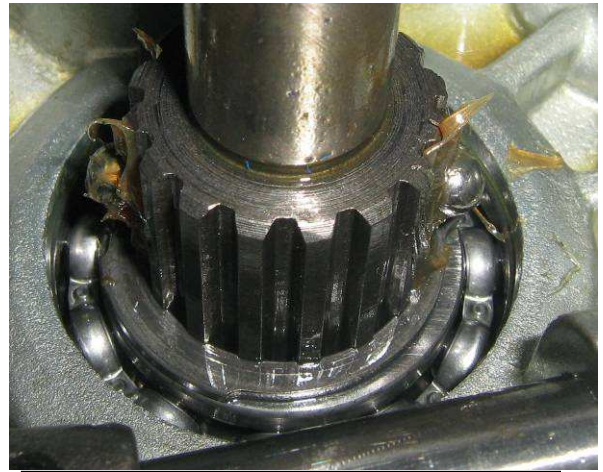
23. STICK THE BALLS INTO THE GREASE BLOBS ON EITHER END OF SPRING HOLE. (HOLE IN THE PLOT: THE INTERNAL PTO SHIFT LEVER IS STILL IN PLACE IN A FEW OF THESE PICS...BAD PHOTO SEQUENCING ON OUR PART, PLEASE IGNORE. RE-ASSEMBLY IS EASIER WITH LEVER **OUT** OF HOUSING.)

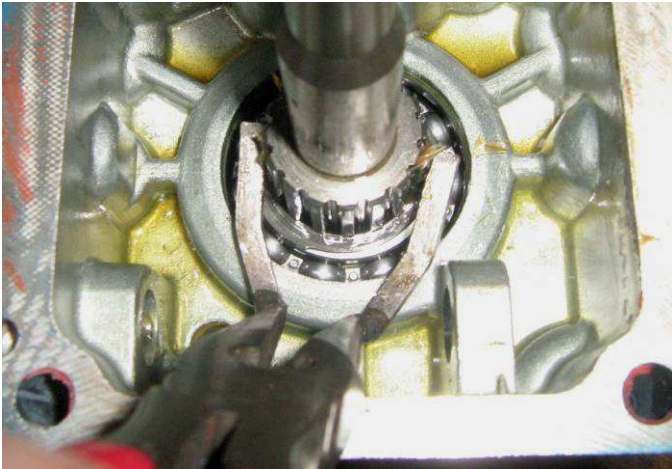
24. BALLS STUCK IN GREASE ON EITHER SIDE OF HOLES IN SHAFT; SPRING IS INSIDE SHAFT (BETWEEN BALLS)

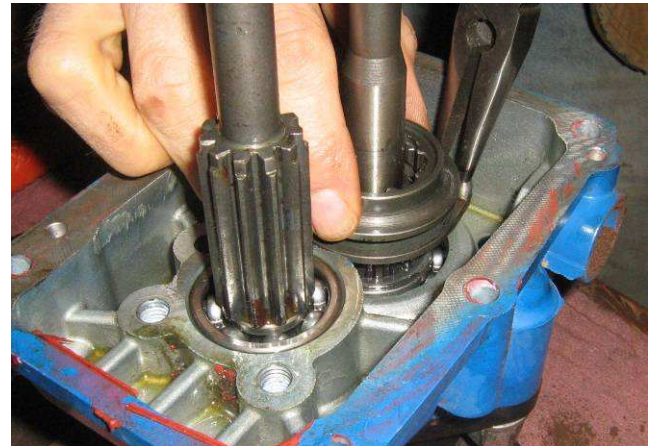
25. USING BCS "PTO TOOL" TO COMPRESS BALLS & SPRING INTO SHAFT BEFORE INSTALLING PTO SLIDER...NOTE POSITIONING OF TOOL. **NOTE:** IT IS BEST TO HAVE THE PTO SHAFT END THAT IS PROTRUDING THROUGH THE COVER CLAMPED IN A VISE FOR THIS PROCEDURE, TO HOLD IT AND THE COVER STILL...THIS PIC WOULD BE LOOKING DOWN.

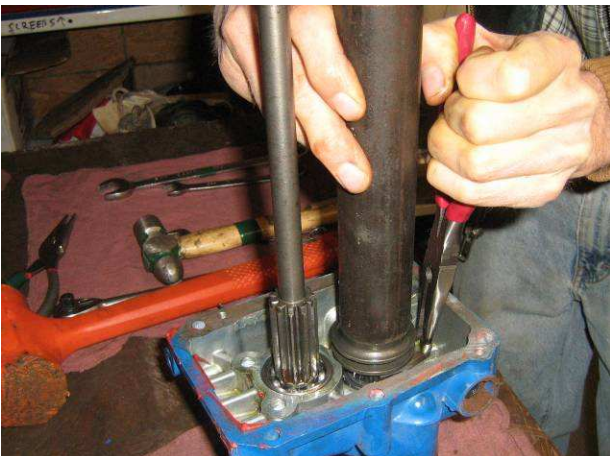
26. SET PTO SLIDER DOWN OVER PTO SHAFT (MAKE SURE IT IS RIGHT SIDE UP, AS IN PICTURE)...IT WILL REST ON TOP OF PTO TOOL "FINGERS". YOU ARE STILL COMPRESSING PTO TOOL AND HOLDING TIGHT, AND NOT MOVING, OR THE BALLS WILL POP OUT...

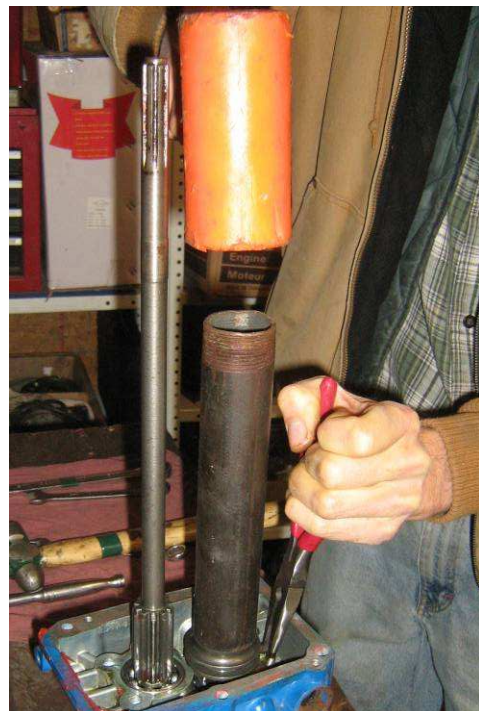
27. TAKE A PIECE OF 1 1/4" STEEL WATER PIPE (10" TO 14" LONG) AND PLACE IT ON TOP OF PTO SLIDER. NOTE DEADBLOW HAMMER TO LEFT...

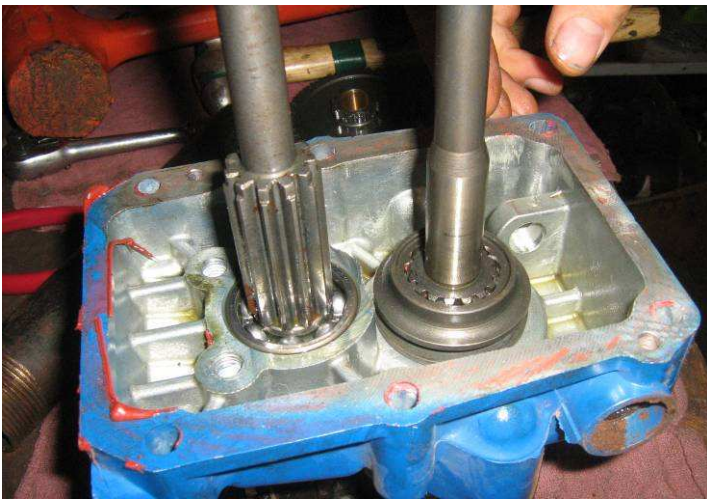
28. STILL HOLDING TIGHT ON PTO TOOL, SMACK DOWN ON PIPE **HARD** WITH HAMMER. SLIDER WILL SHOVE PTO TOOL FINGERS DOWN OFF BALLS AND BALLS WILL BE TRAPPED INSIDE SLIDER (IF ALL GOES WELL). **INSPECT INSIDE OF HOUSING CAREFULLY** TO MAKE SURE A BALL DID NOT "ESCAPE"!! (IF IT DID, MAKE SURE SPRING IS OK, AND REPEAT PROCEDURE UNTIL CORRECT.)

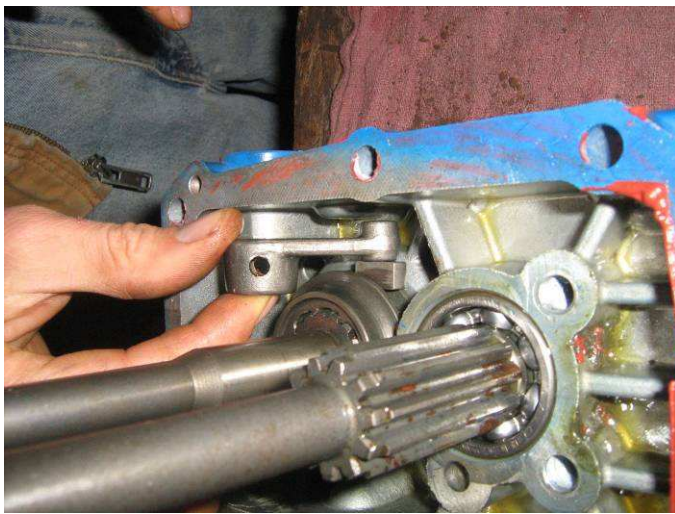
30. INSERT "SHOE" INTO INTERNAL PTO SHIFT LEVER...MAKE SURE TO GET IT IN CORRECT SIDE!!

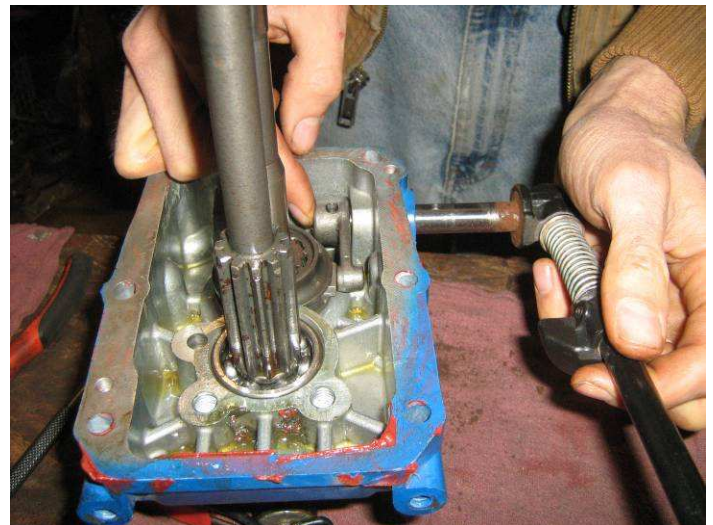
31. SET INTERNAL PTO LEVER DOWN INTO HOUSING, ENGAGING SHOE INTO GROOVE IN SLIDER

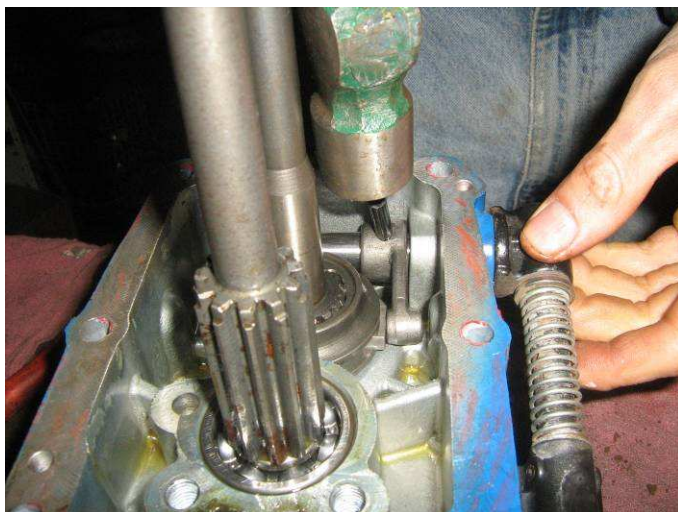
32. INSERT OUTER PTO LEVER THROUGH HOLE IN HOUSING, ALIGNING WITH INTERNAL LEVER (**NOTE:** IF YOU HAVE REPLACED THE PTO COVER, **MAKE SURE** YOU HAVE INSTALLED THE LITTLE OIL SEAL IN THE HOLE WHERE THIS LEVER COMES THROUGH THE HOUSING, OR YOU WILL HAVE AN OIL LEAK!!)

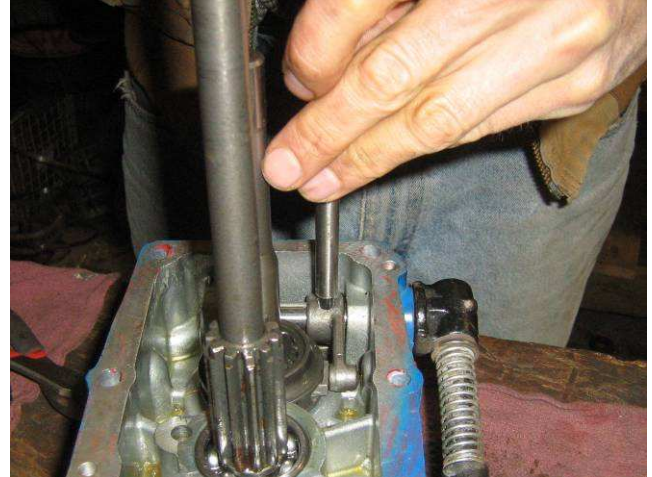
33. START ROLL PIN INTO HOLE...

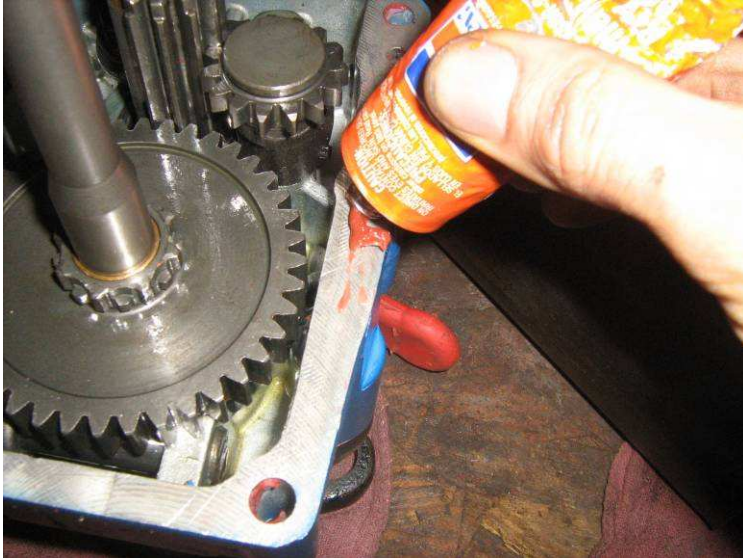
36. USING A RAZOR BLADE, SCRAPE ALL THE OLD SILICONE GASKET SEALER OFF THE COVER, AND THE TRANSMISSION HOUSING. (THIS CAN BE DONE ANYTIME BEFORE NOW, AS WELL)

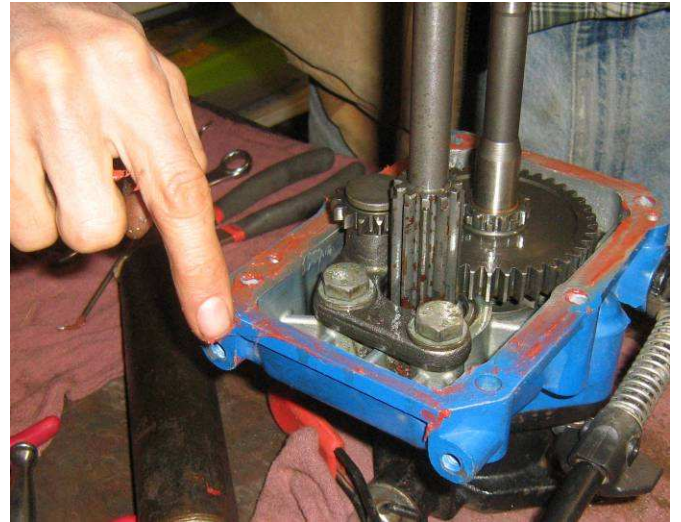
37. USING RED OR BLUE RTV SILICONE GASKET MAKER / SEALER, APPLY A THIN LAYER TO THE GASKET SURFACE. YOU CAN SPREAD IT THIN WITH YOUR FINGER. THIS STUFF IS AVAILABLE AT ANY AUTO PARTS STORE.

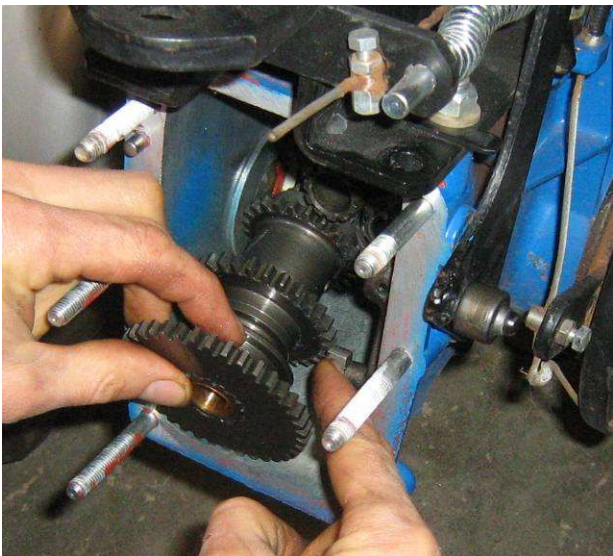
38. SPREADING IT AROUND BY FINGER. YOU DON'T NEED LOADS OF THE STUFF ON THERE.

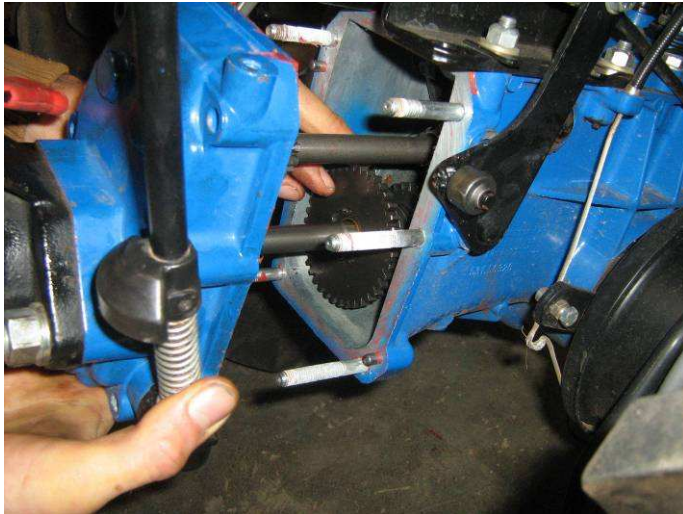
42. SLIDE PTO COVER ASSEMBLY BACK ONTO TRANNY.

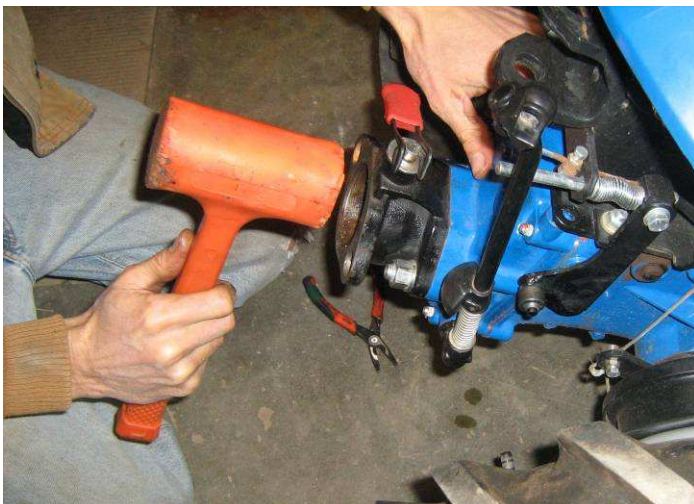
44. ROTATE GEARS A BIT WITH YOUR FINGER (OR A SCREWDRIVER) AS YOU ARE PUSHING COVER ON, TO MAKE SURE EVERYTHING IS LINING UP. CAREFUL NOT TO WIPE THE SILICONE FROM THE GASKET SURFACE...

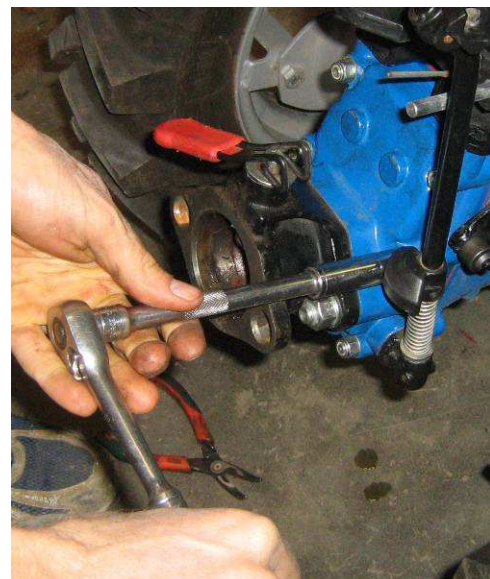
45. TAP COVER INTO PLACE WITH DEADBLOW OR RUBBER Mallet. YOU SHOULD NOT HAVE TO PUT MUCH FORCE INTO PROPERLY GETTING THE COVER ON....IF IT GOES ON REALLY HARD IN THE LAST BIT...**STOP!** SOMETHING IS NOT LINED UP RIGHT; TAKE IT BACK OFF AND INSPECT, ROTATE GEARS, ETC.

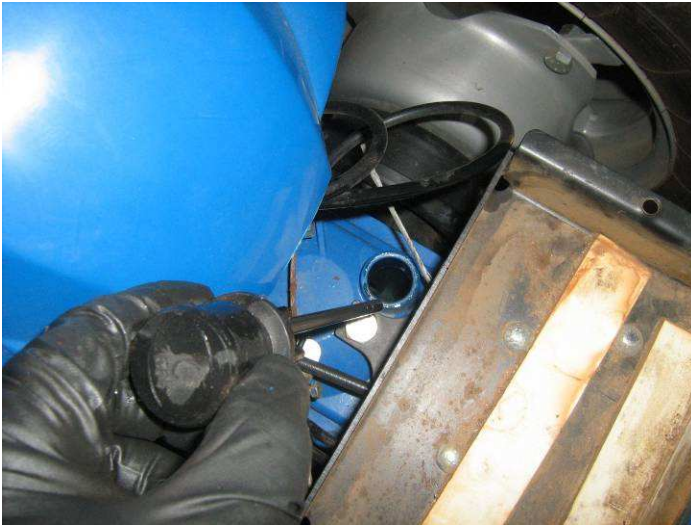
48. INSTALL PTO SHIFT ROD, WASHER AND COTTER PIN.

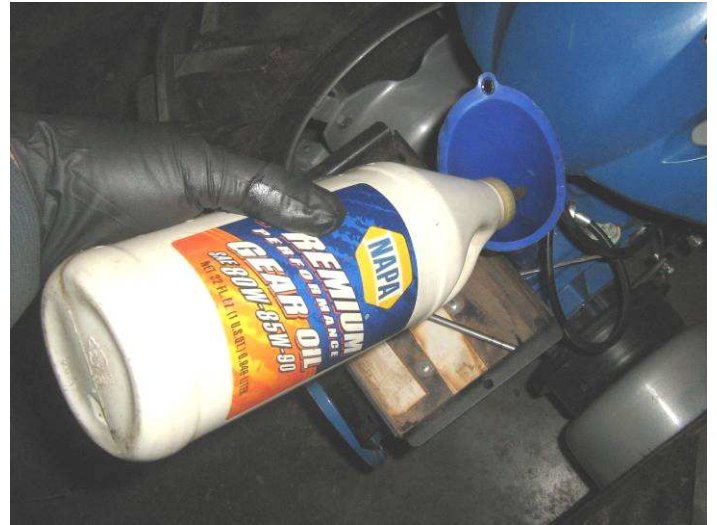
49. LET TRACTOR SIT FOR AT LEAST ONE HOUR SO SILICONE GASKET MAKER CAN SET UP. AFTER MAKING SURE TRANSMISSION OIL DRAIN PLUG IS TIGHT, REMOVE OIL FILLER / DIPSTICK FROM TOP OF TRANNY...
